Technical Service BULLETIN

REAR HATCH KNOCKING NOISE

'05 – '06 Scion tC

NV010-06
H/VH

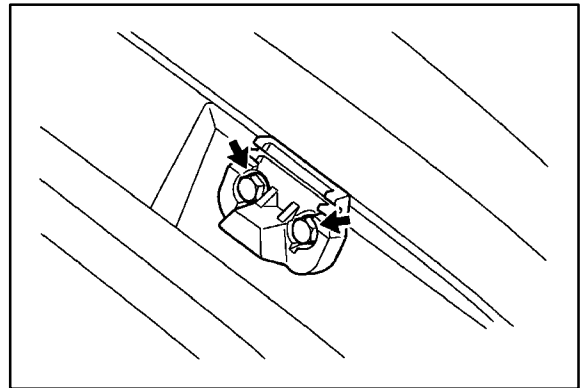
Introduction Some customers may experience a knocking noise from the rear hatch when traveling over rough roads. Follow the repair procedure in this bulletin to correct this condition.

- Remove the back door lower stopper cushion on the left and right side by removing the 2 bolts.
- Install a NEW stopper cushion on the left and right side with 2 bolts.
Torque: 4.0 N•m (41 kgf•cm, 35 in.·lbf)
