Introduction Some customers may complain that the cover on the side of the seat back pulls away from the bezel for the access lever or reclining adjuster lever. Parts have been modified to correct this condition. Please refer to the following repair procedure to correct affected vehicles.

- Applicable Vehicles**
- **2005 – 2006** model year **Scion tC** vehicles produced **BEFORE** the Production Change Effective VIN shown below.

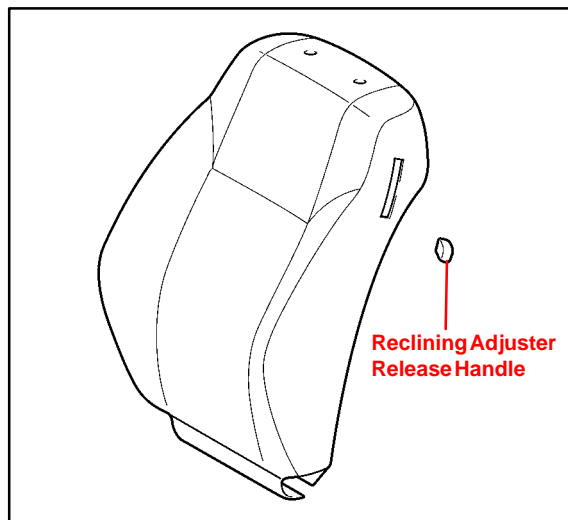
1. Remove the reclining adjuster release handle.

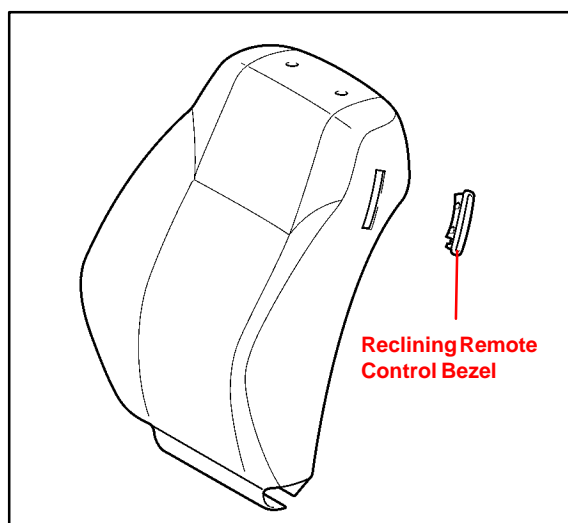
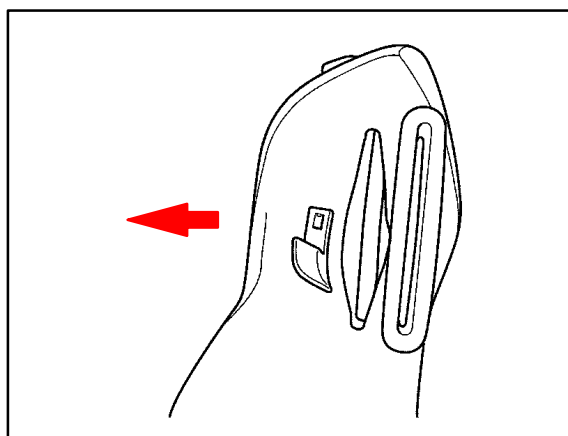
2. Remove the reclining control bezel.

- Gently pull the control bezel to remove.
- Be sure to NOT damage the bezel during removal.

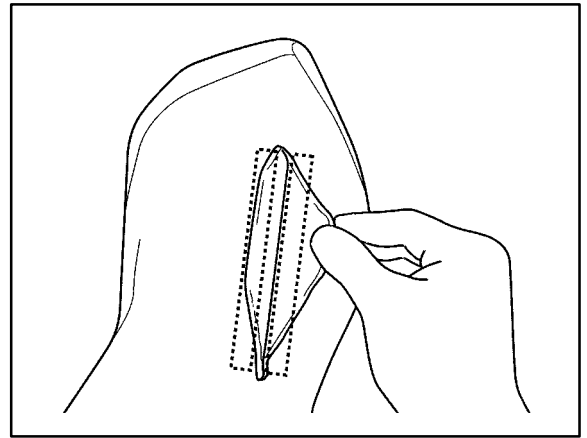
3. Apply double-sided tape to the seat pad for the front seat back cover fitting (for front and rear).
Apply the double-sided tape along the outer edge of the seat pad opening.

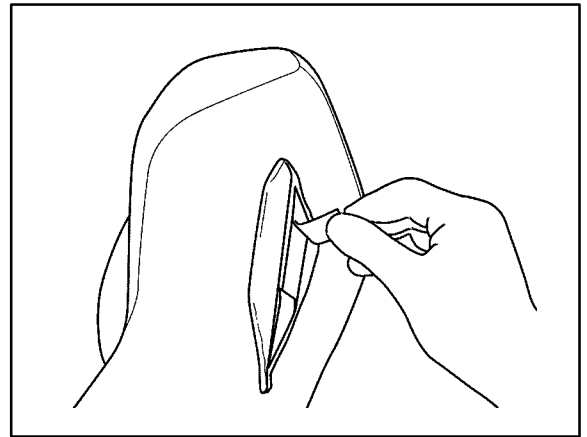
4. Carefully remove the backing from one side of the double-sided tape.

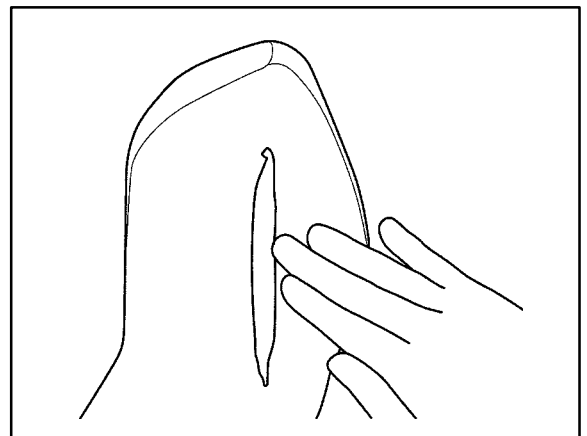
5. Press the front seat back cover against the tape adhesive side.

- Do NOT attempt to remove the tape once applied to the cover.
- Do NOT reuse the tape if removed once.

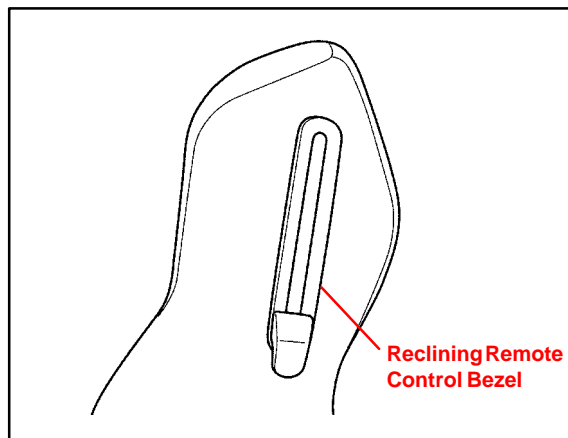
6. Install the reclining control bezel by pressing it firmly into place.

Allow it to set for 30 minutes for proper adhesion.

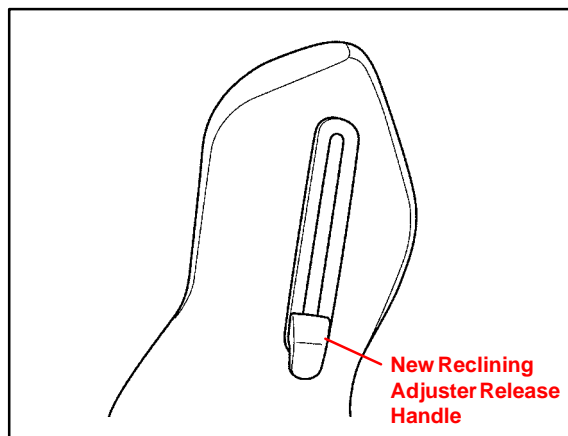
7. Install the NEW reclining adjuster release handle.

Since the reclining adjuster release handle may be deformed when removing, do NOT reuse the original reclining adjuster release handle.
